APPENDIX C – PHOTOGRAPHIC OVERVIEW

Existing Water System Condition

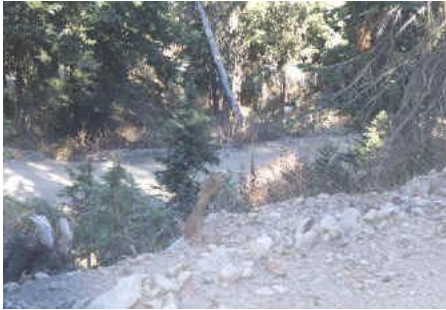
Curve/Switchback

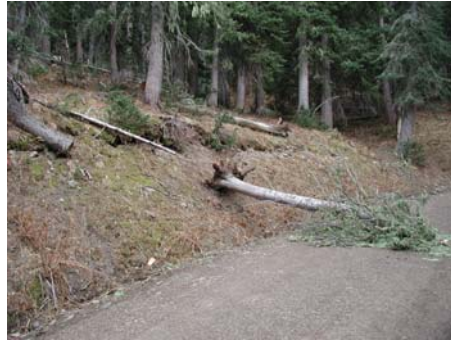
Hazard Tree Fallen from Cut Bank

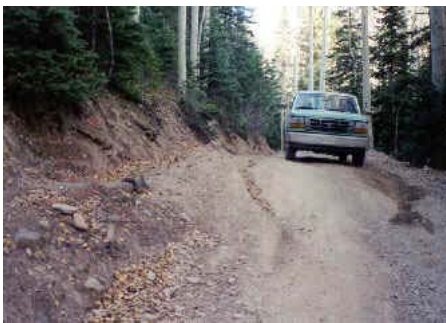
Pipeline Crossing

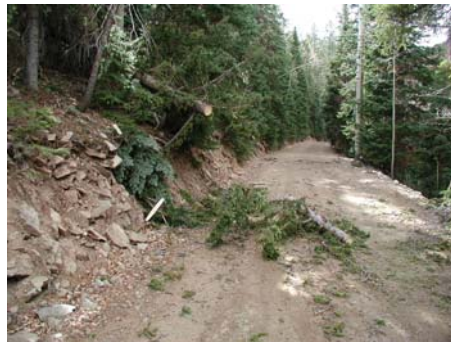
Hazard Tree Felled by Wind

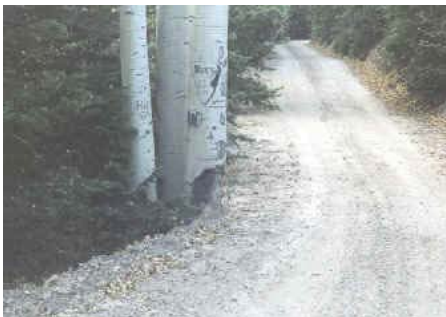
Hazard Trees in Road Surface

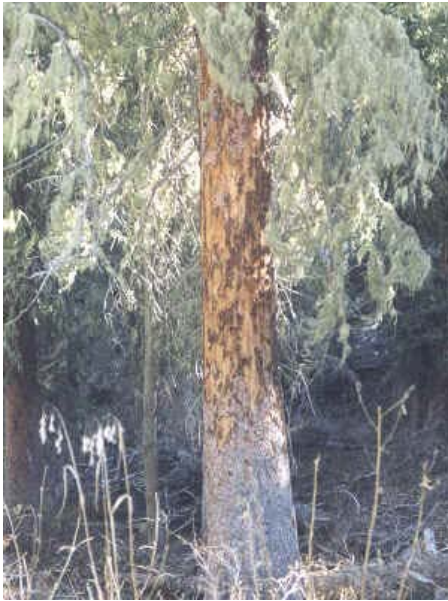
Spruce Beetle Killed Tree

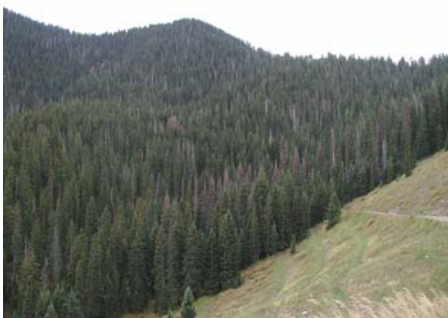
**Upper North Creek
Spruce Beetle Killed Trees**

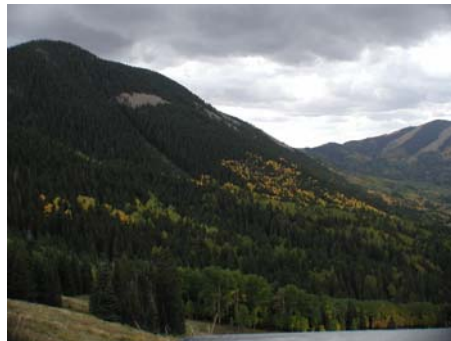
**Upper Indian Creek
Conifer Encroachment in Aspen**
